## Test Report No. P50-11-0157e

## Environmental Tests

**Specimen:** 1 piece distribution board series "Vector II"  
VE412PN (specimen No. 50-11-3039-1)

**Objective:** Proof of the degree of protection IP6X

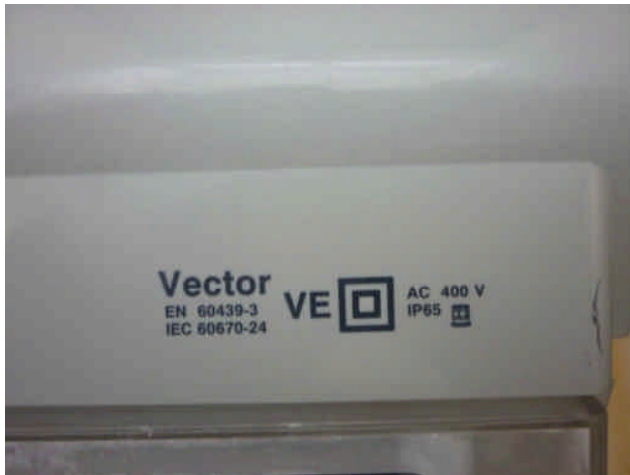
RST/5B50Q89L/25926

fig. 1  
type plate

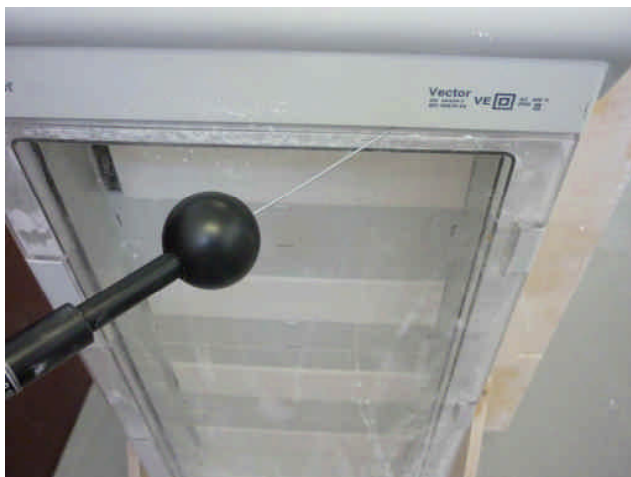
RST/5B50Q89L/25919

test means:	access probe (rigid steel wire 1.0 mm diameter, 100 mm length, edges rounded off)
test force:	1 N ± 10 %
acceptance conditions:	The access probe must not be able to penetrate.

fig. 2  
test of the protection against access with an  
access probe (IP6X)

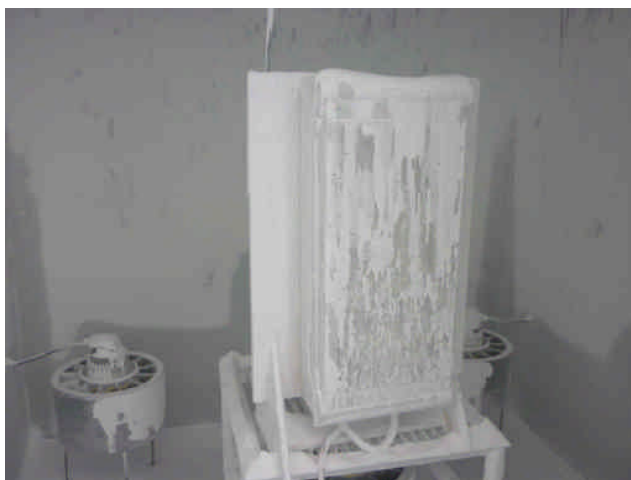
RST/5B50Q89L/25925

fig. 3  
specimen in the dust chamber after the dust  
test (IP5X)

- underpressure in the enclosure: 17 mbar
- extraction rate: 0,93 enclosure volumes / hour
- resulting test duration: 8 hours

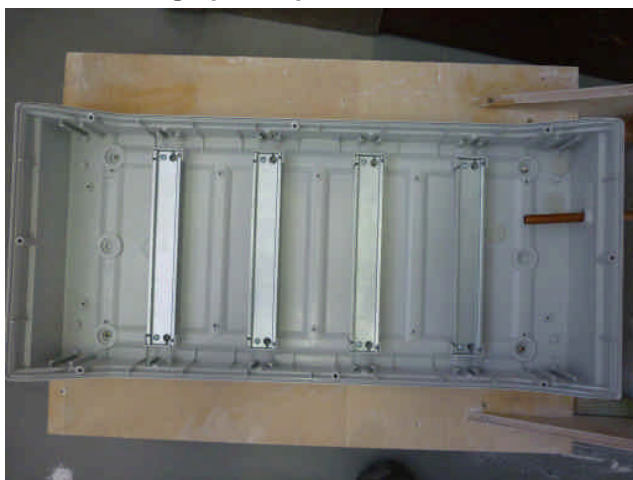
RST/5B50Q89L/25921

IP6X: No dust penetrated into the distribution board VE412PN during the dust test (see fig. 4 and fig. 5). The access to the hazardous parts with an access probe was not possible.

fig. 4  
after the dust test:  
no dust penetrated

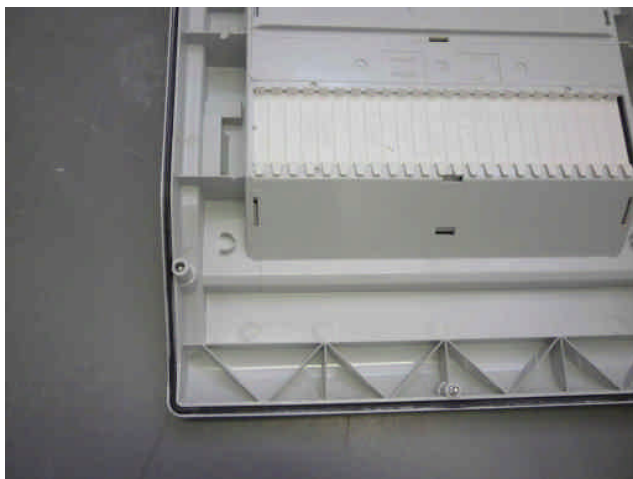
RST/5B50Q89L/25922

fig. 5  
after the dust test:  
seals of the distribution board are effective  
(no penetration of dust)
